STRUCTURAL INTEGRITY RESERVE STUDY

The Gardens of Kendall South Condominium No.4 Association, Inc.
10845 SW 112th Ave, Miami, FL 33176

Prepared by: Gregorio Batista, PE, CGC, and Kristian Cano
Inspected on: December 11, 2024
Prepared on: December 20, 2024

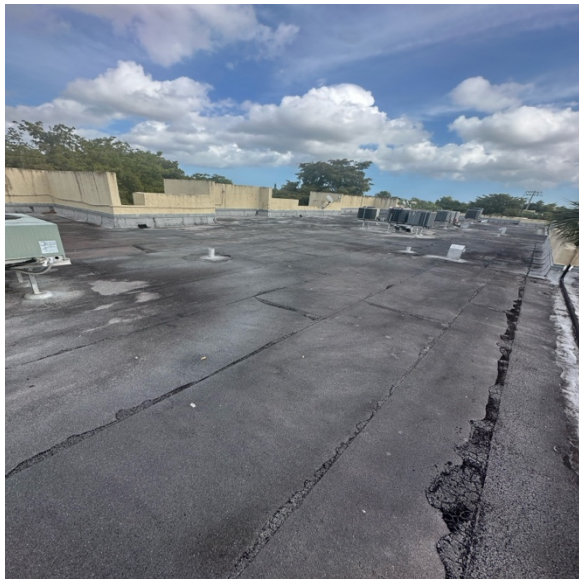
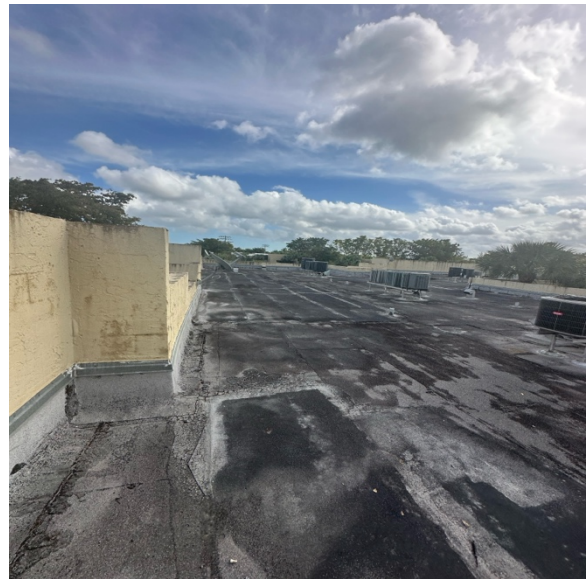
Condition: The roof is in satisfactory conditions.

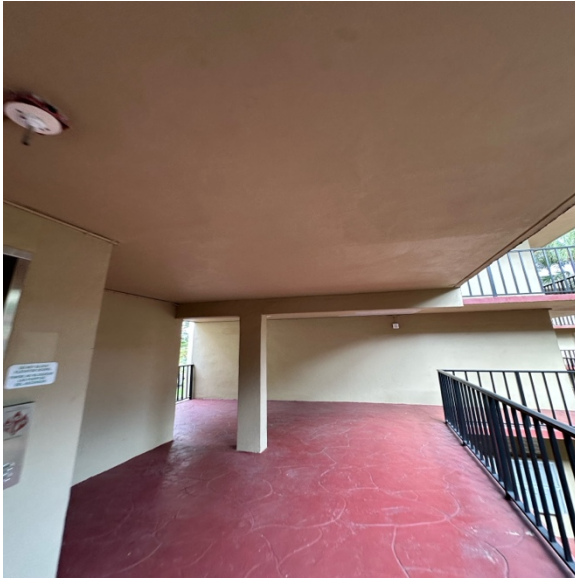
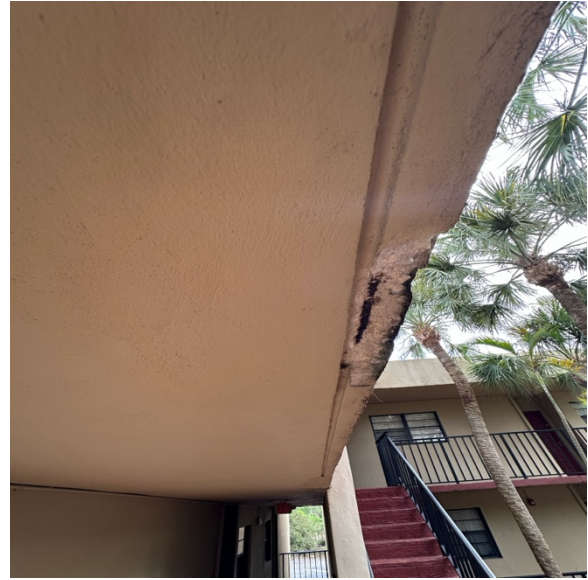
Condition: The concrete framing and floor systems is in fair condition.

Remaining Lifespan: Although concrete is a very durable material, due to the location's proximity to the coast, spalling due to rebar corrosion usually manifests before the concrete naturally deteriorates. It is important to note that it is rarely possible to visually inspect and examine all the concealed construction, nor should be generally necessary. Our conclusions are based upon our experience and conditions examined in the exterior typical structural members of the building. Refer to the table presented at the end of this report.

Estimated Cost of Replacement: Concrete repairs are typically done on a unit-price basis and should be repaired as damages appear. Refer to the table presented at the end of this report for our recommendation based on our experience and the size of the building.

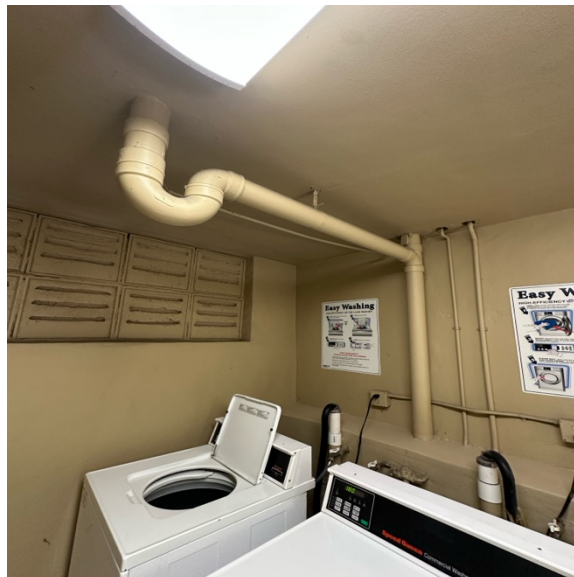
Condition: The plumbing system is in satisfactory condition. It is important to note that it is rarely possible to visually inspect and examine all the concealed construction, nor should be generally necessary. Our conclusions are based upon our experience and deficiencies found in the visible and readily accessible areas.

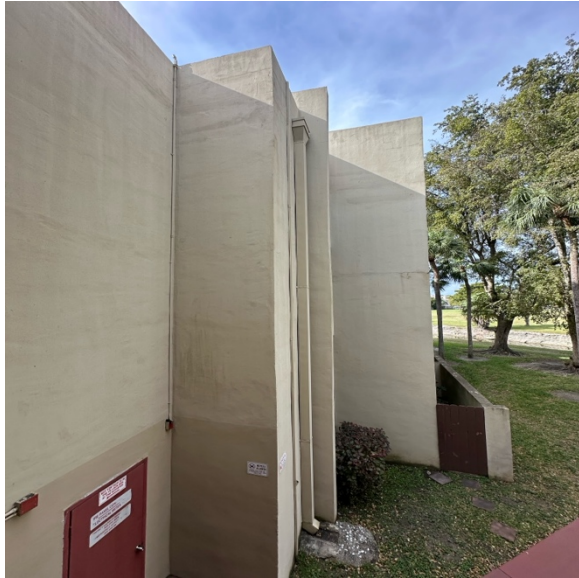
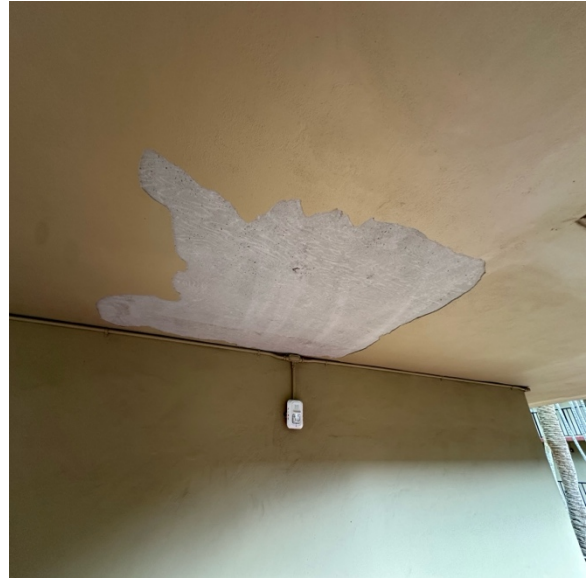
Condition: The exterior stucco is in fair condition. It is important to note that our conclusions are based upon our experience and deficiencies found in the visible and readily accessible areas.

Remaining Lifespan: Although the stucco is a very durable material, due to the location's proximity to the shore, spalling due to rebar corrosion usually manifests before the stucco naturally deteriorates. Refer to the table presented at the end of this report.

Estimated Cost of Replacement: The removal and replacement of all the stucco finish is rarely required. It is typically repaired as required in the building for general maintenance. Therefore, we assume that 20% of all exterior surfaces are required to be replaced at once. See the table presented at the end of this report for our recommendation based on our experience and the size of the building. (The exact amount of area needing replacement will be discretionary based on the actual future conditions and the desired appearance).

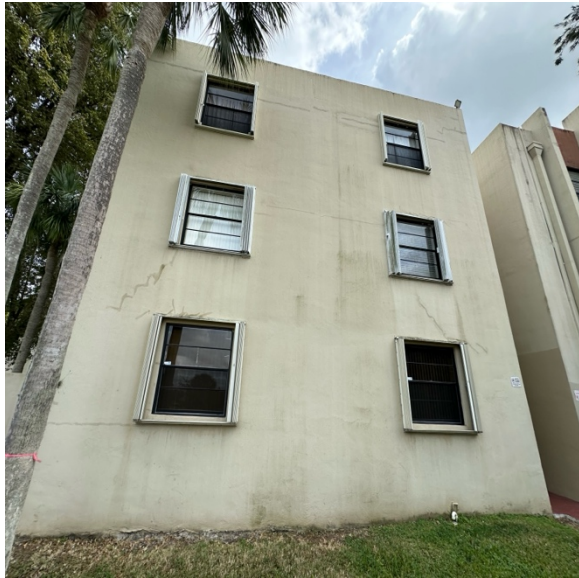
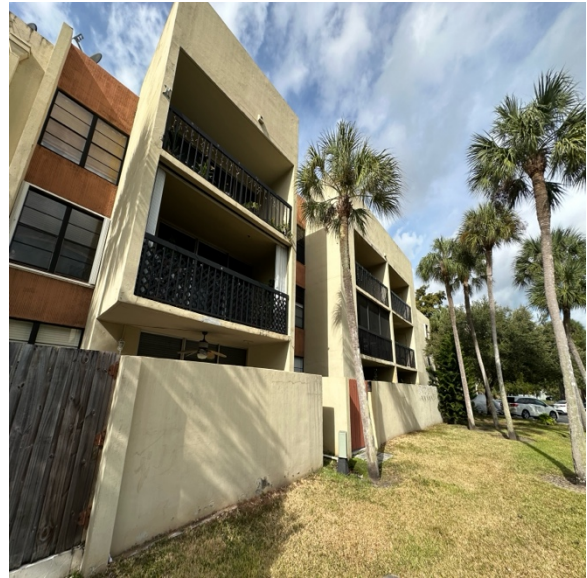
Condition: The surfaces appear to be in fair condition.

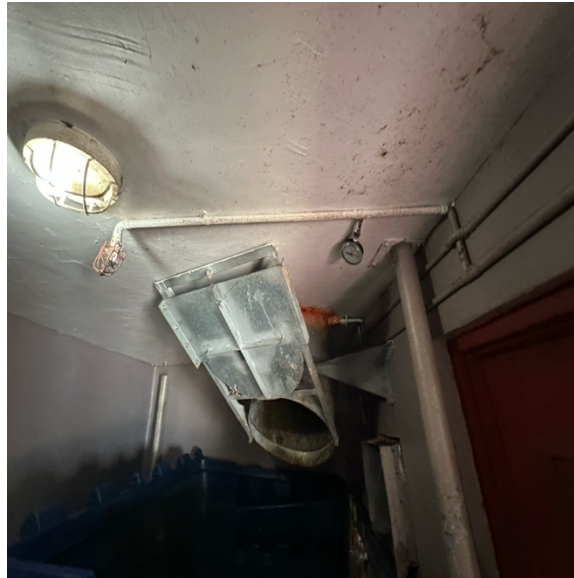
Condition: The fire protection systems appear to be in fair condition.

Estimated Cost of Replacement: Fire protection systems such as the ones observed in the building are typically not replaced in their totality but are replaced as required. See the table presented at the end of this report for our recommendation based on our experience and the size of the building.

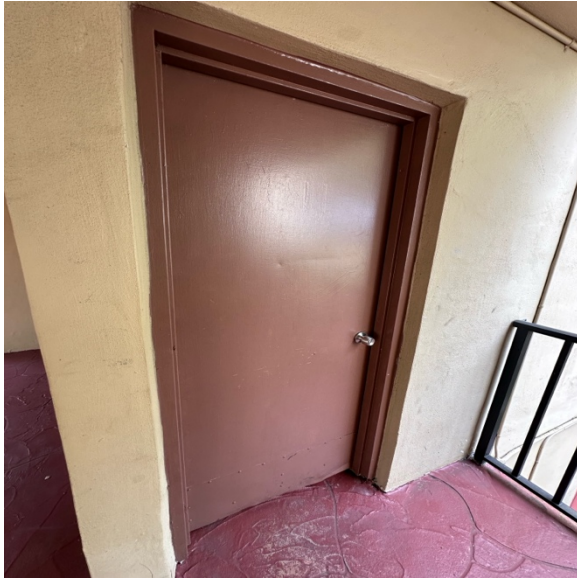
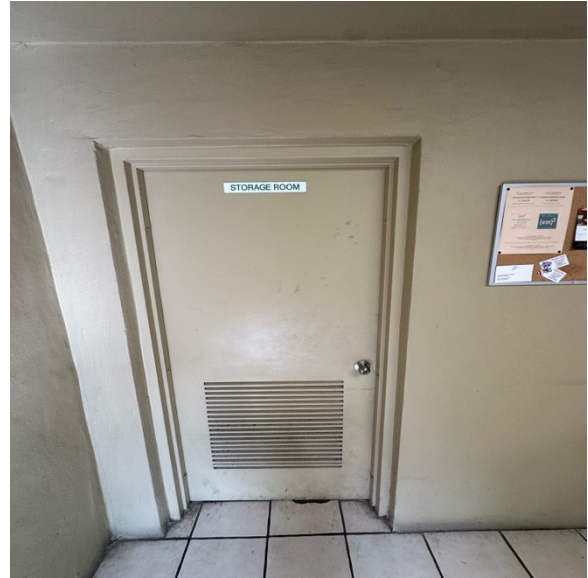
Condition: The common area doors appear to be in satisfactory condition. The association is only responsible for the common areas. The units' windows and doors are the unit owner's responsibility. At the time of our inspection, no common area windows were noted.
